Stoneridge  
SP-2013-0096D  
Site Photos

## ENVIRONMENTAL BOARD VARIANCE APPLICATION TEMPLATE

Re: **Stoneridge Principal Road Adjustment Variance. SP 2013-0096D**

REPORT OF  
CITY OF AUSTIN  
ENVIRONMENTAL ASSESSMENT

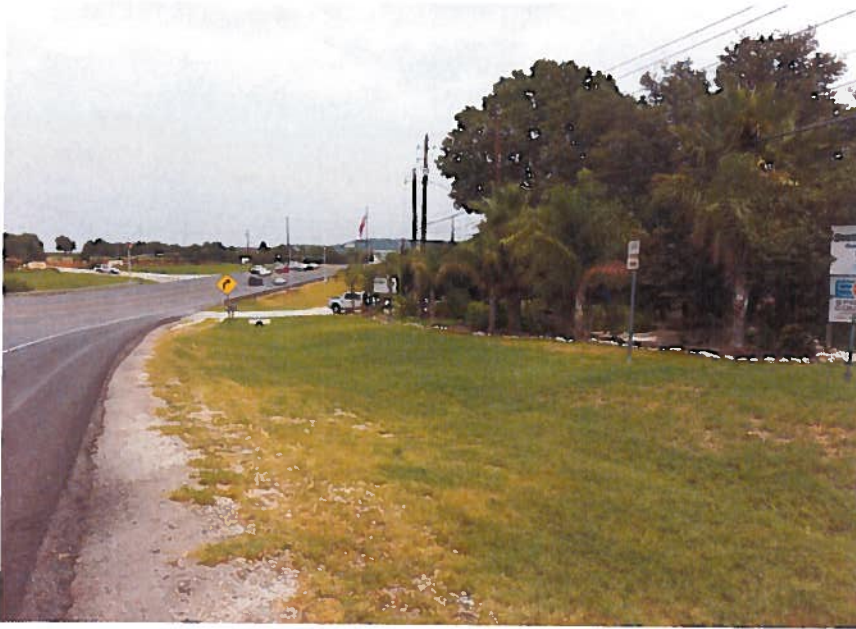
North perimeter frontage along FM 2244 to traffic light

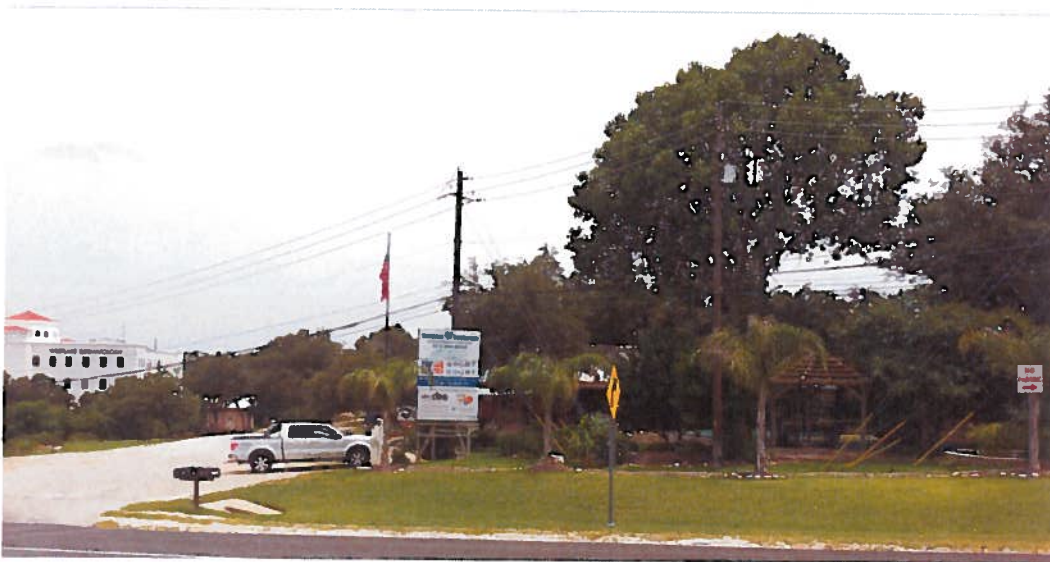
Existing commercial development onsite

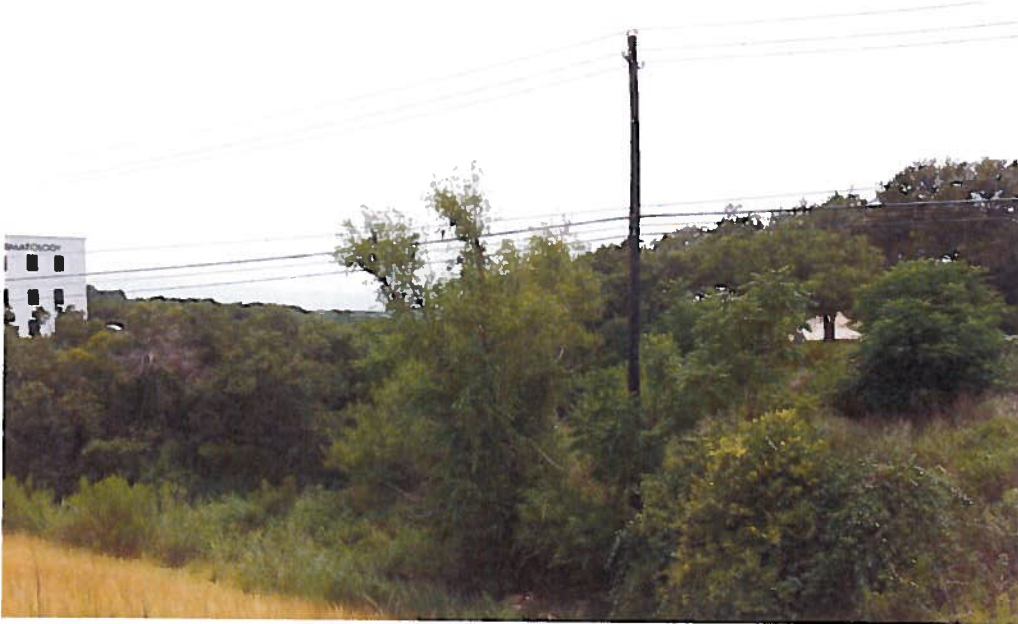
Slope areas on east side of property looking south

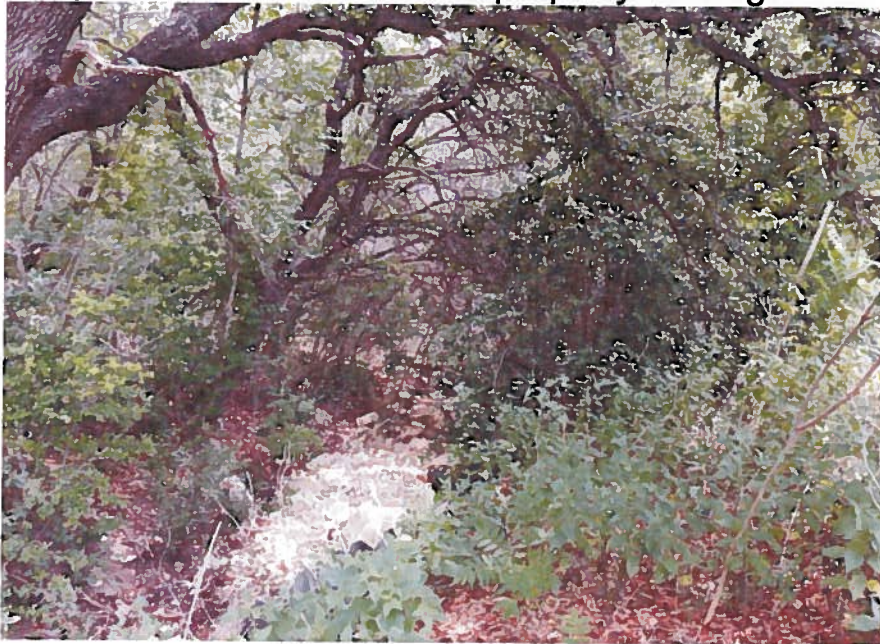
Unclassified tributary on east part of the site looking south

All storm water runoff from the property flows across the property as sheet flow toward a north-to-south trending wet-weather drainage feature located in the east-central part of the property (refer to Figure 3 of Appendix A). The wet-weather drainage feature collects storm water runoff primarily from a relatively significant water shed to the north of Bee Cave Road, and serves as a tributary to Barton Creek located approximately one mile south of the subject property. According to review of a FEMA Flood Insurance Rate Map, no portion of the subject property lies within the 100-year floodplain. However, based on evidence of high-water markings along the wet-weather drainage feature, it is believed that a significant volume of runoff flows via this feature across the subject property during significant precipitation events.

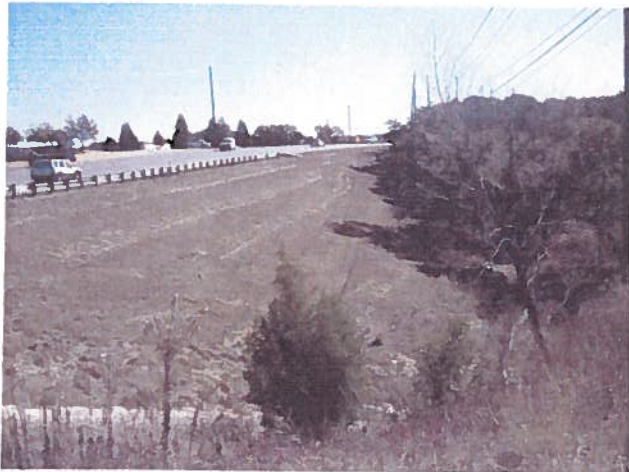
Figure 4 Drainage/Guardrail ROW

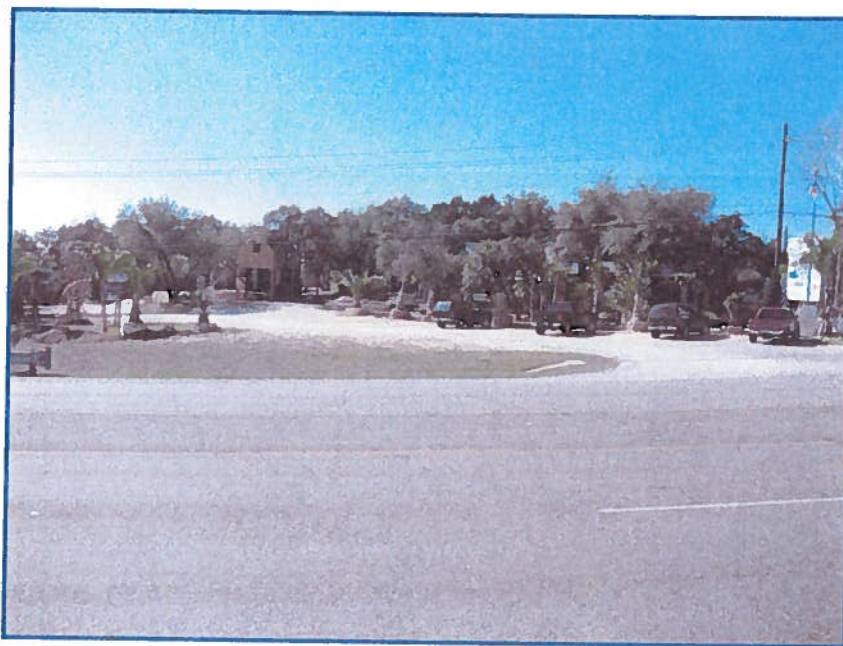
PHOTOGRAPHIC REPORTING DATA SHEET  
[ PHOTOGRAPH 1 ]

**Description:** View of the subject property with Bee Cave Road in the foreground. Photograph taken from Bee Cave Road facing south.

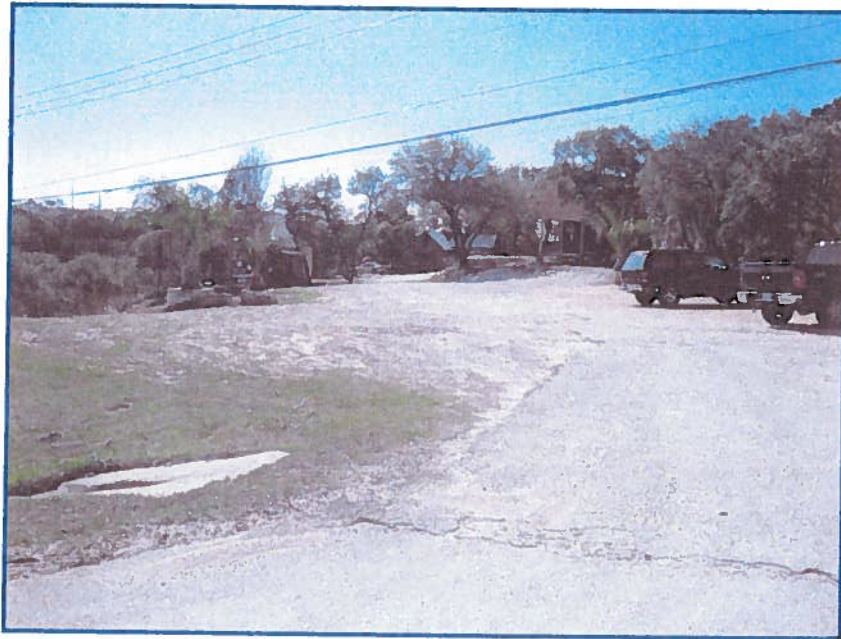
PHOTOGRAPHIC REPORTING DATA SHEET  
[ PHOTOGRAPH 2 ]

**Description:** View of the western (partially developed) portion of the subject property, developed with several small buildings and gravel driveway. Photograph taken from Bee Cave Road facing south-southeast.

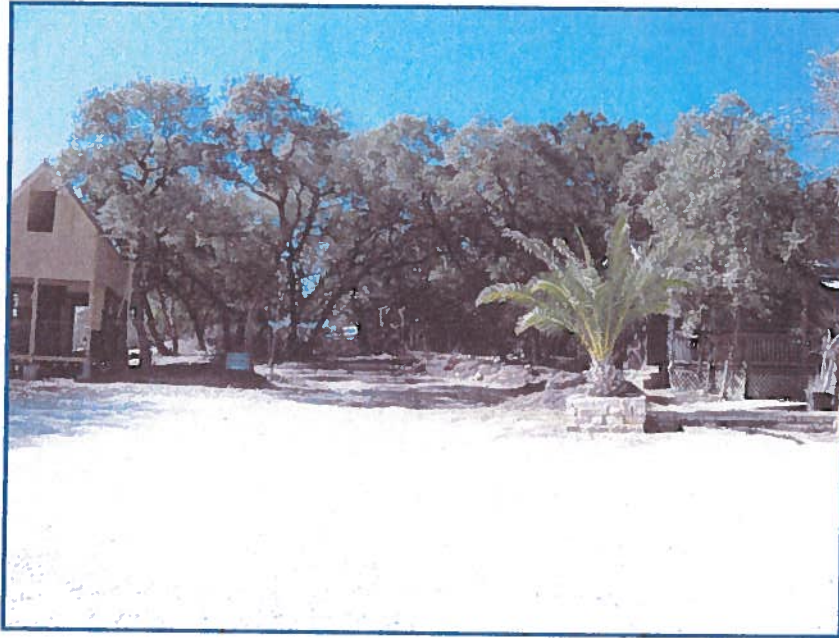
PHOTOGRAPHIC REPORTING DATA SHEET  
[ PHOTOGRAPH 3 ]

**Description:** Typical view of large vegetation of Vegetation Zone A on the western portion of the subject property.

Large Vegetation:      Approximately 95% Plateau live oak (*Quercus fusiformis*); 4- to 10-inch trunk diameters; several trees with up to 16-inch trunk diameters  
                                    Approximately 5% Ashe juniper (*Juniperus ashei*); 6- to 14-inch trunk diameters

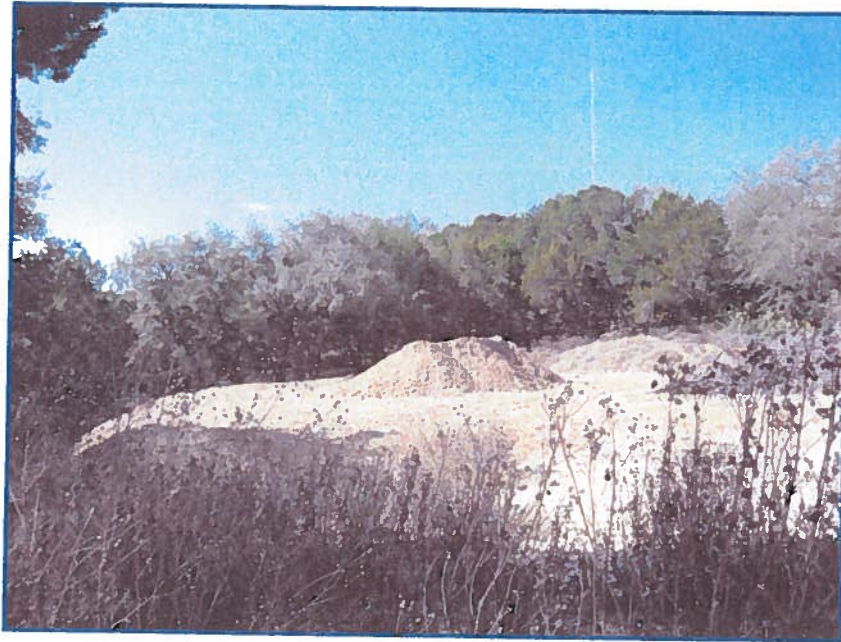
PHOTOGRAPHIC REPORTING DATA SHEET  
[ PHOTOGRAPH 4 ]

**Description:** Typical view of large vegetation of Vegetation Zone B on the eastern portion of the subject property, and clearing/soil storage area.

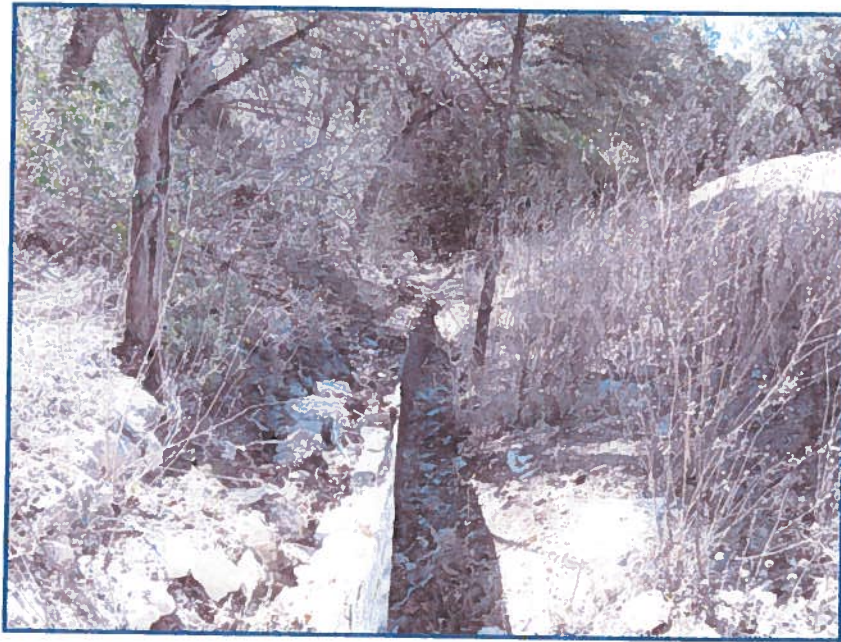
PHOTOGRAPHIC REPORTING DATA SHEET  
[ PHOTOGRAPH 5 ]

**Description:** View of the wet-weather drainage feature in the east-central portion of the subject property.

Based on observations made across the entire subject property, no sinkholes or other recharge features were identified on the property (Note: there was no evidence observed of "pooling" in the wet-weather drainage feature on the property).

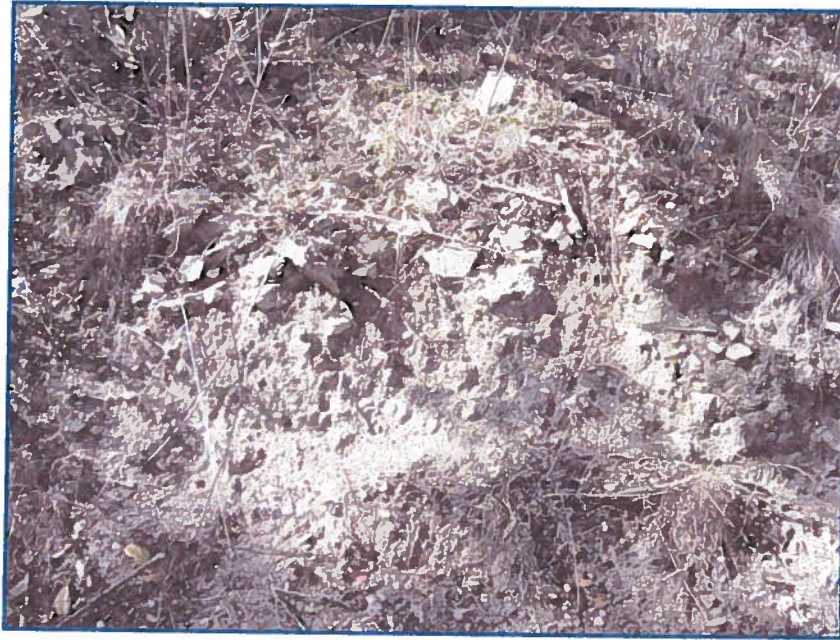
PHOTOGRAPHIC REPORTING DATA SHEET  
[ PHOTOGRAPH 6 ]

**Description:** View of typical soils on the subject property.

Soil Component Name:	Brackett soils, rolling (BID)
Soil Surface Texture:	Light brownish-gray gravelly clay loam to approximately 6 inches; underlain by very pale brown clay loam with scattered rock fragments to about 12 inches; underlying material is interbedded limestone and marl
Hydrologic Group:	Permeability is moderately slow; available water capacity is low
Soil Drainage Class:	Moderately well drained
Depth to Bedrock:	Approximately 10 – 12 inches (observed in the field)
Soil Component Name:	Brackett soils and Rock outcrop, steep (BoF)
Soil Surface Texture:	Approximately 35 percent Brackett soils, 21 percent rock outcrop, and 40 percent soils similar to Brackett soils.
Hydrologic Group:	Permeability is moderately slow; available water capacity is low
Soil Drainage Class:	Moderately well drained
Depth to Bedrock:	Approximately 5 – 12 inches (observed in the field)

As is depicted in Figure 4 of Appendix A, Brackett soils (BID) are reported to cover the northern-most portion of the property while the central and southern portions of the property are covered with Brackett soils and Rock outcrop. Using a shovel, several shallow excavations were made at various locations on the subject property and observations of the soil characteristics confirmed the presence of soils similar to those described in the *Soil Survey* (refer to the photograph in Appendix B). Areas of the property covered by gravel driveways were observed to have very thin underlying soils.

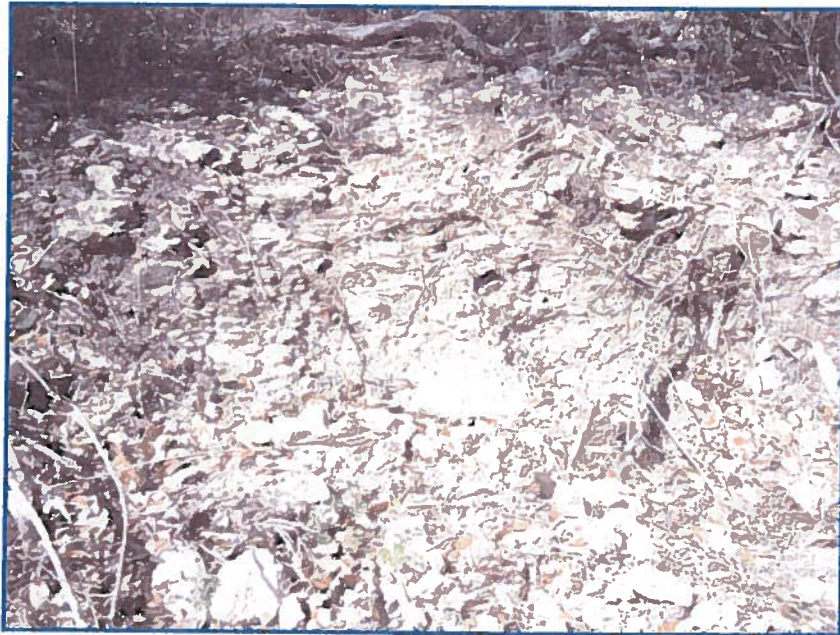
PHOTOGRAPHIC REPORTING DATA SHEET  
[ PHOTOGRAPH 7 ]

**Description:** View of typical geologic outcrops on the subject property.

Given the soil cover on the subject property, only broken (loose) exposed rock fragments of the Glen Rose as well as isolated areas of true rock outcrops were observed, primarily along slope breaks. These geologic materials were observed to be comprised of light gray, hard to medium-hard limestone as well as medium-hard marly material (refer to photograph in Appendix B). The greatest concentration of exposed outcrops was observed just east of the development area – along the topographic slope break.
